Terraprobe

September 21, 2023

File No. 3-21-0151-54

D4 LANDFILL IMPACT ASSESSMENT UPDATE PART OF LOTS 47, 48 AND 49 CONCESSION 12, TOWN OF COLLINGWOOD, COUNTY OF SIMCOE, ON – EAST PROPERTY

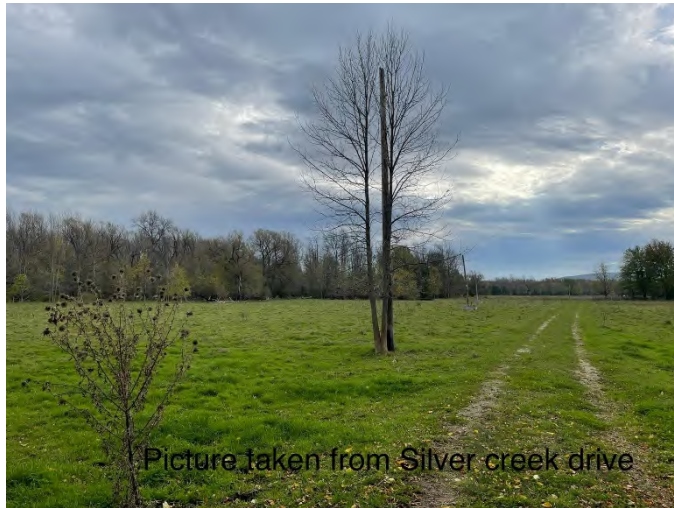
Photograph 1

Description: Viewing South to the property at
5 Silver Creek Drive,
Collingwood

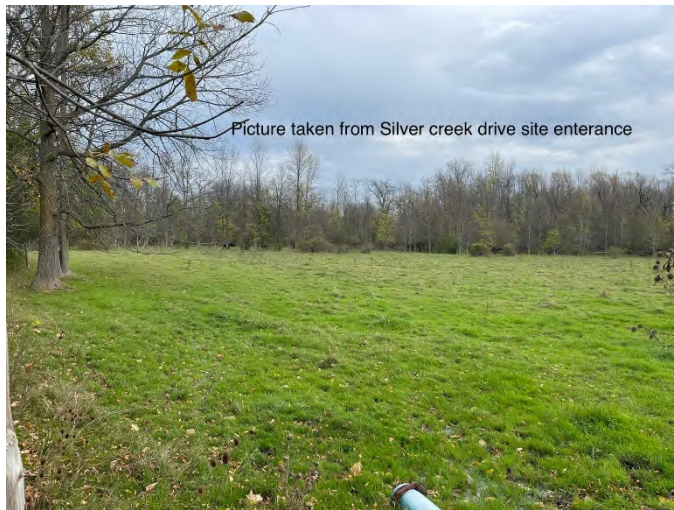
Photograph 2

Description: Viewing East from Silver
Creek Drive, at the entrance to
the (the Property)

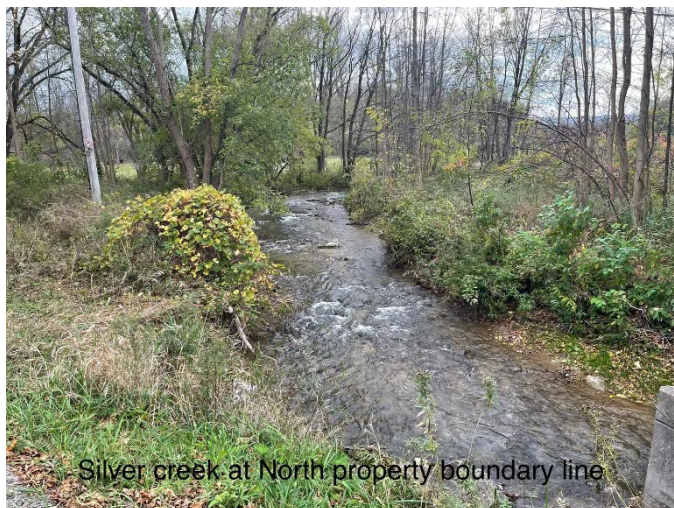
Photograph 3

Description: Viewing Silver Creek at the
north of the Property

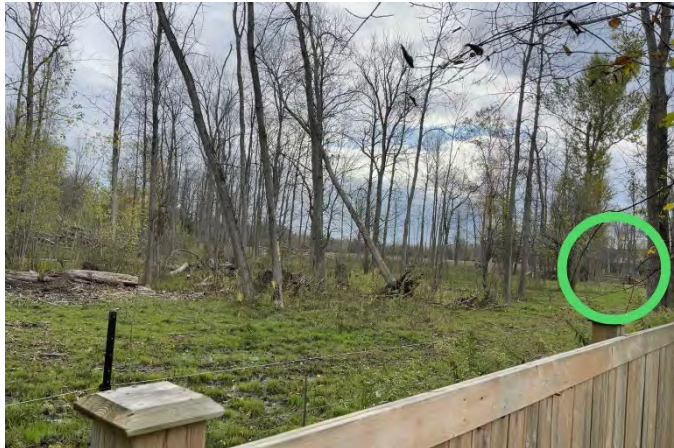
Photograph 4

The D4 Impact Assessment completed in January 2011 indicated that the East Property was undeveloped vacant land covered with grass and trees. The latest inspection completed at the East Property in October 2021 indicated the presence of a wooden barn located in the southwestern corner of the adjacent West Property. Other parts of the Property are noted to be of similar condition to those described in the January 2011 D4 Assessment report by Terraprobe.

Description: Viewing the barn located at the
west of the Property

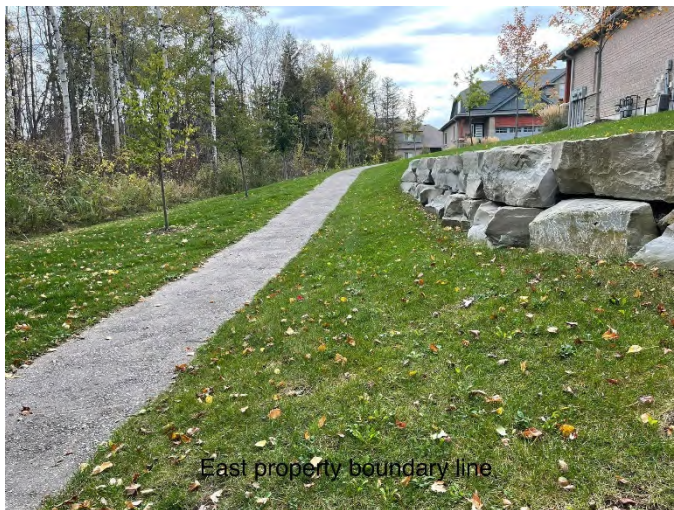
Photograph 5

Description: Viewing the site located at 5
Silver Creek Drive, Collingwood

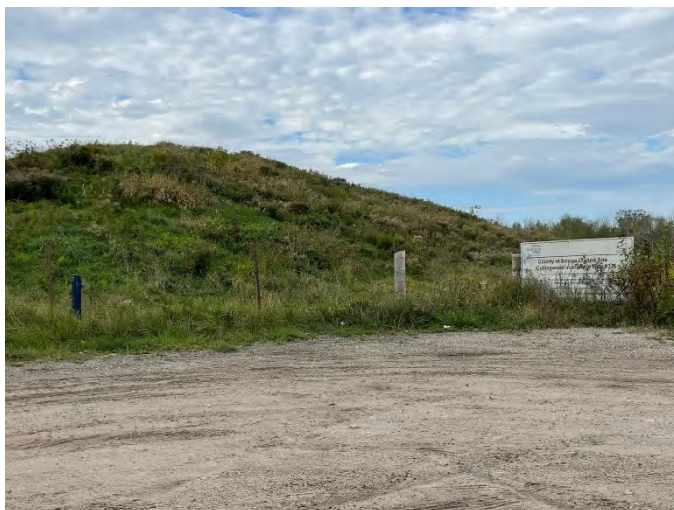
Photograph 6

Description: Viewing Closed landfill located
southwest of the Property

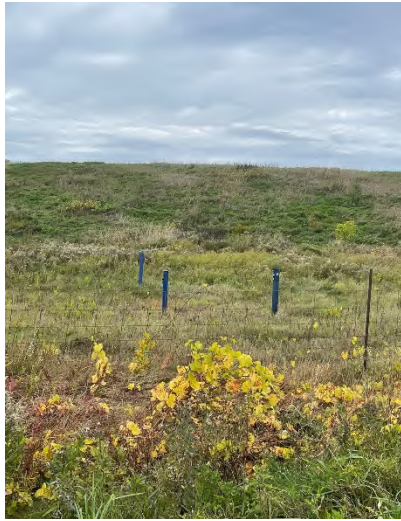
Photograph 7

Location: Monitoring wells at landfill site, southwest of The Property

Description: Viewing the landfill site, southwest the Property located at 5 Silver Creek Drive, Collingwood
