**PROJECT:** Town of Collingwood  
Class EA Amendment for the R. A. Barker Water Treatment Plant Expansion  
Ainley Job No. 119013

#### WTP Condition Assessment

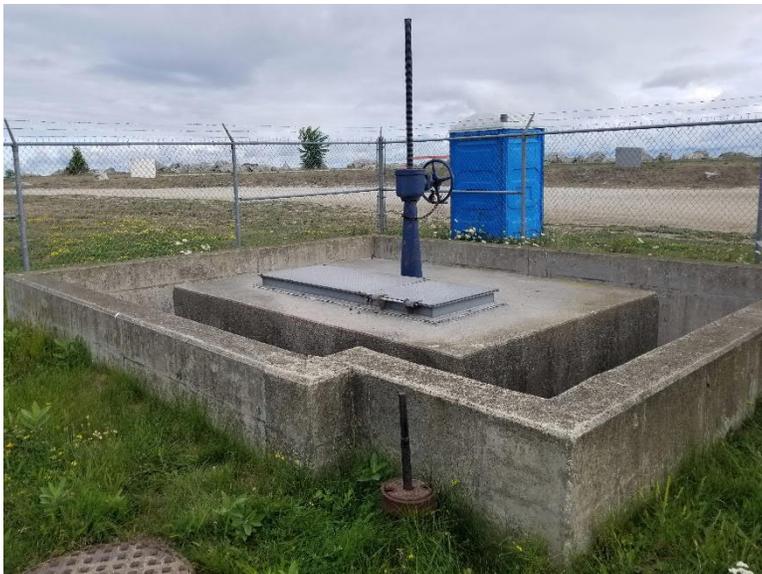
**Figure 1 Surge Chamber**

- The surge chamber tank structure is in fair condition (Figure 1).
- Ponding water was noted at the ground level in the trough.
- Ground level steel covers show light to medium corrosion (Figure 2).
- There were two 1.5m long cracks observed in the concrete side wall (south), each crack ranging from 5mm to 8mm wide (Figure 3).

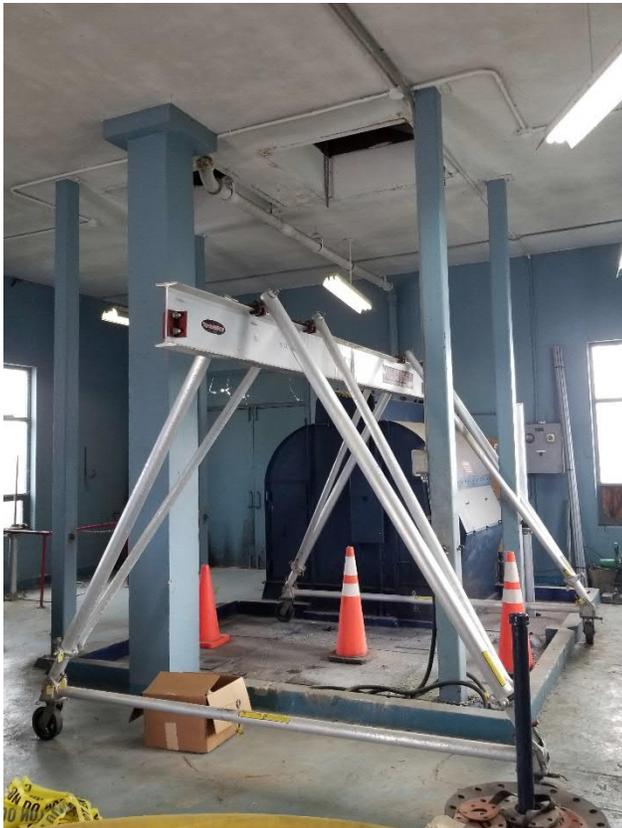
**Figure 4 Raw Water Building - Additional Steel Columns**

- From visual inspection, it appears that the roof openings were installed in a later phase of construction, such that four additional steel columns were installed to support the existing roof structure (Figure 4).
- Local roof underside stain is a sign of leakage through a crack (Figure 5).

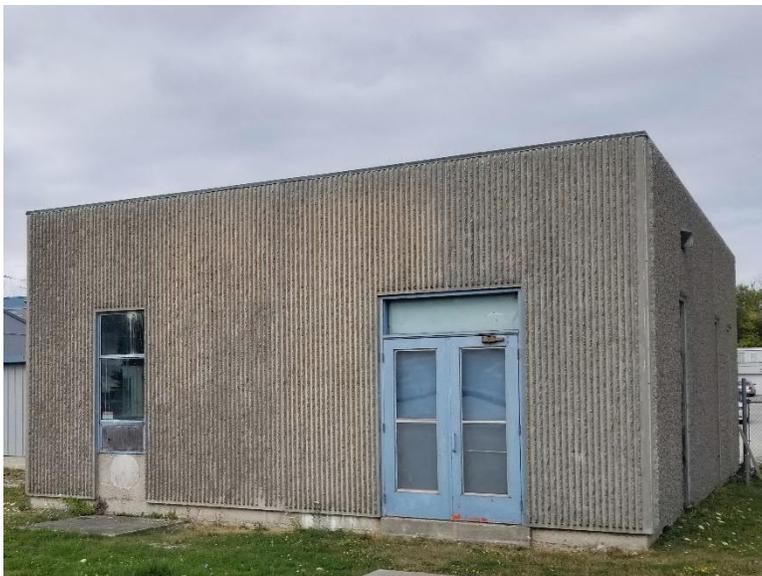
**Figure 6 Raw Water Building – External Structure**

- The structure of the building appears to be in a relative good state of repair but the building is in poor condition requiring a complete shell refurbishment including items such as, but not limited to, windows, doors, roofing, louvres, precast panels, checker plates and hatches (Figure 6 and Figure 7).
- In the current state with the floor checker plate hatches failing and marked off with pylons, it is recommended a more permanent barrier to protect from the hazard is installed if the building is maintained (Figure 4).

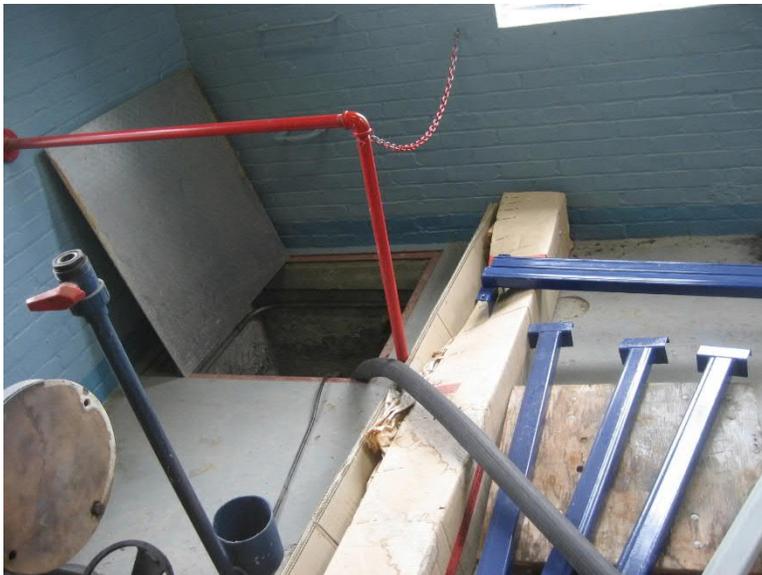
**Figure 8 Industrial Building – Basement**

- A basement with access at the NE corner was noted (Figure 8).
- Abandoned pump bases were observed on the ground floor (Figure 9).
- Deteriorated concrete floor (combination of scaling and erosion in medium range) with significant cracks were noted (Figure 10, Figure 11 and Figure 12).

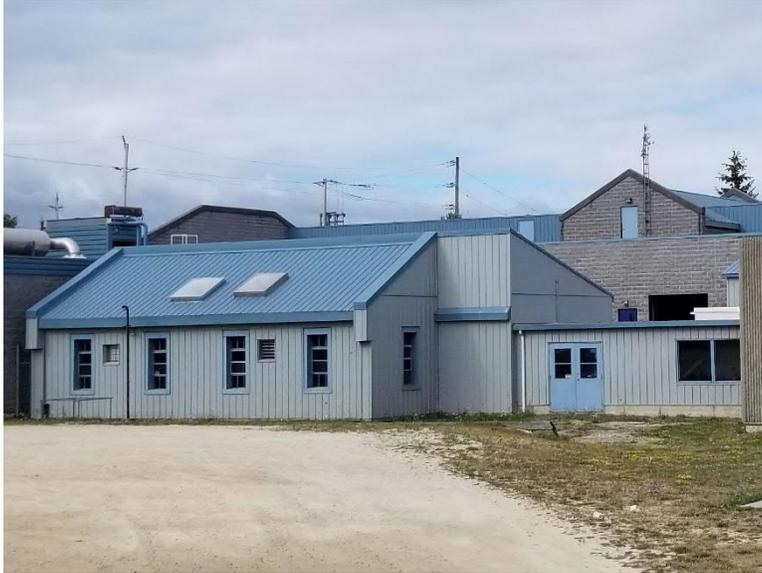
**Figure 13 Industrial Building - Structure**

- The building superstructure appears to be in a reasonably good state of repair with no significant leaks other than into the basement (crawl space.) The building has been re-cladded with metal siding, but the old single pane windows require replacement (Figure 13 and Figure 14).
- The epoxy flooring is worn and peeling and requires refinishing (Figure 10, Figure 11 and Figure 12).
- The hollow metal doors and frames are beginning to rust and will require replacement (Figure 15).

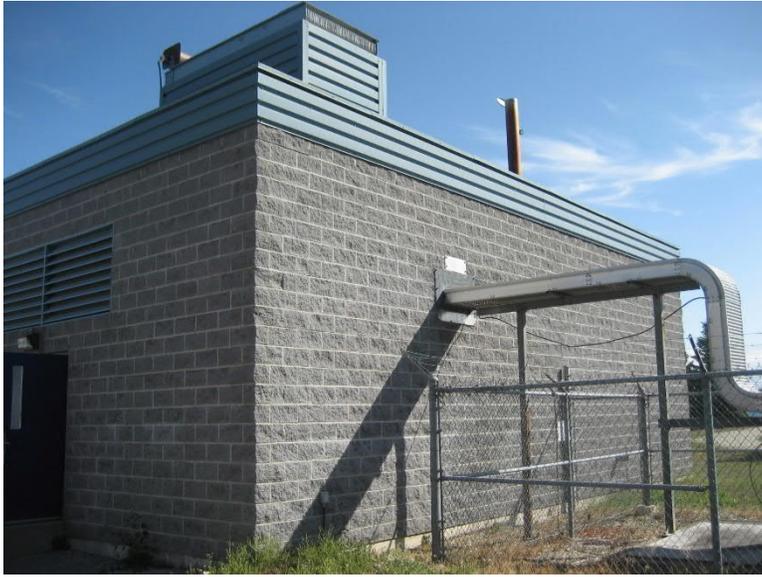
**Figure 16 Diesel Generator Building - Exterior**

- The generator building structure is in good condition (Figure 16 and Figure 17).

- The generator building is in good condition (Figure 16).
- The epoxy floor coating is delaminating from the wall and there is evidence of a leak (Figure 18).
- The front steps of the building require some resurfacing and asphalt repair as it presents a trip hazard (Figure 19).
- The fuel fill station steps are constructed of wood and show signs of age and are recommended for replacement with an open grating type frame to allow snow and ice to shed in the winter which would mitigate health and safety concerns (Figure 20).
- A substantial amount of fuel is stored in the generator building and it is recommended the applicable codes be reviewed to determine if the generator room meets the current codes and allowable volumes indoors.
- The exterior access ladder to the roof requires a safety cage as per Section 18 of the regulations for industrial establishments.

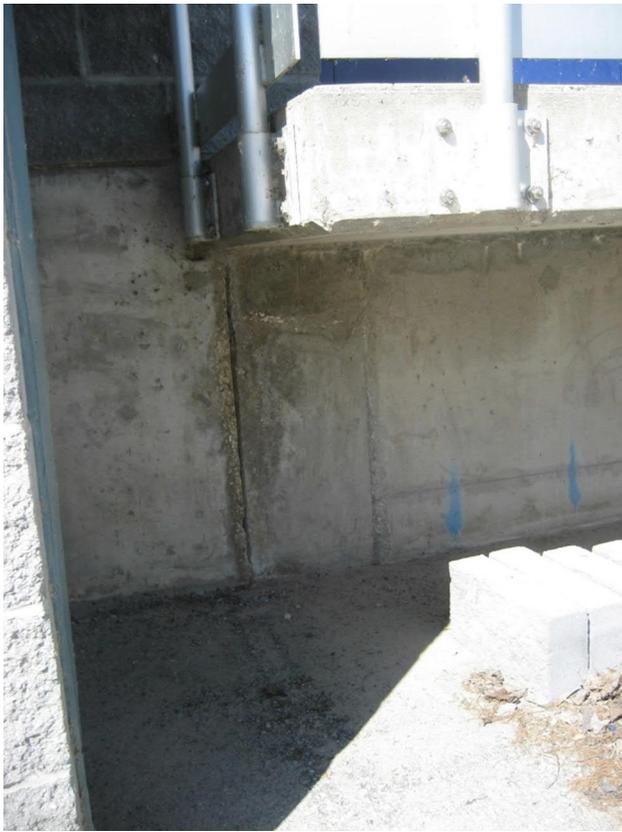
**Figure 21 Main Plant Building – Exterior - Interface between Permeate/Concentrate Pump Room/Tank and Chlorine Contact Chamber Tank #1**

- One cold joint above grade was observed in the east wall exterior face, which is at the interface between the Permeate/Concentrate Pump Room/Tank and the Chlorine Contact Chamber Tank #1 (Figure 21).
- At the SW corner of the main building, a diagonal step crack in the mortar joints of the concrete block wall was noted. At the bottom of the façade wall crack, a concrete crack continued into the basement wall (Figure 22 and Figure 23).
- The south elevation pipe box cover has a top concrete slab that is severely cracked and masonry walls that are cracking and deteriorating. The slab and the walls require extensive repairs (Figure 24).

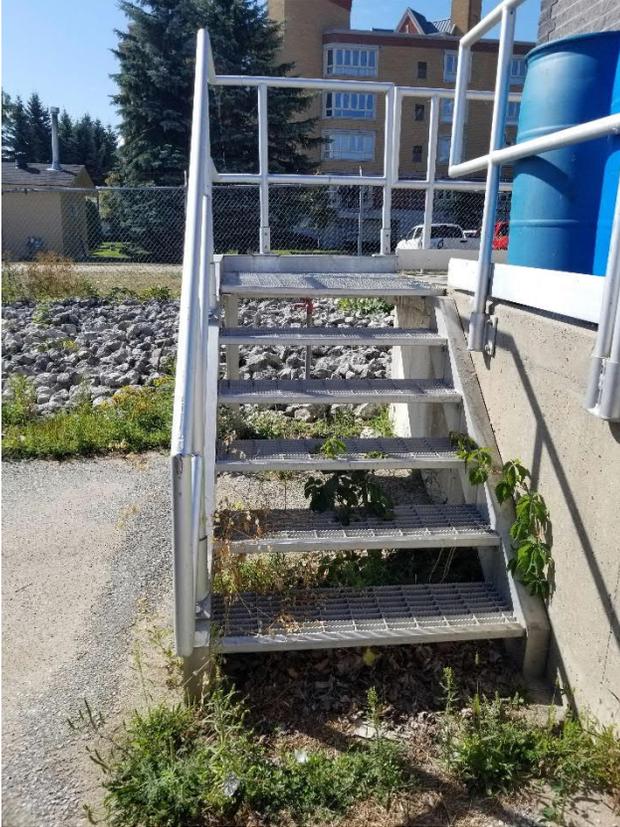
**Figure 25 Main Plant Building – Exterior - Loading Dock Stairs**

- The loading dock stairs are overgrown at the bottom and needs to be clean up for health and safety (Figure 25).
- The loading dock stair handrail is too large in diameter and does not meet code for a graspable handrail (Figure 26). Moreover, the guard rail is damaged and broken.

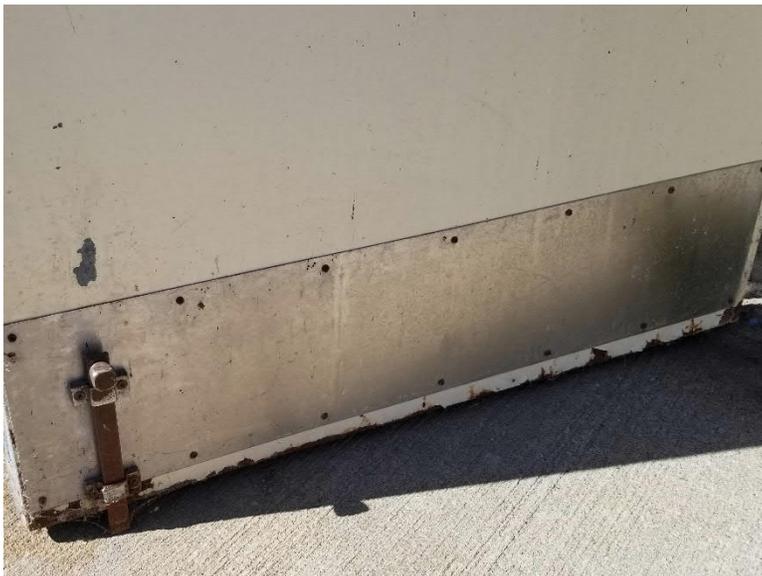
**Figure 27 Main Plant Building – Exterior - Hollow Metal Doors**

- The exterior hollow metal doors and frames throughout are aging and have varying level of rusting most notable at the door and frame bottoms. Weather stripping on several doors is missing or damaged (Figure 27).

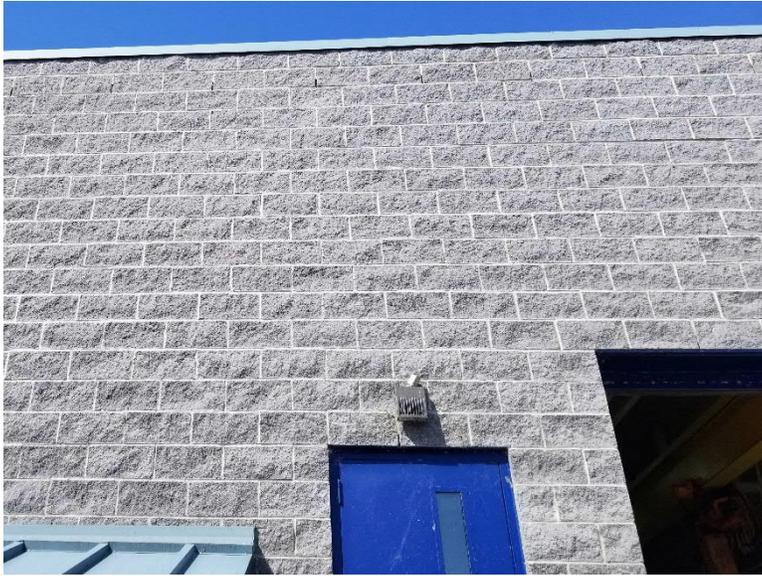
**Figure 28 Main Plant Building – Exterior - East Wall**

- On the east exterior wall, there is a settlement crack next to the overhead door to the membrane room that requires repointing (Figure 28).
- The exterior windows are showing significant signs of corrosion and most notably on the inside which is a result of using hollow metal and non-thermally broken aluminum. All exterior windows require replacement with new aluminum windows (Figure 29).

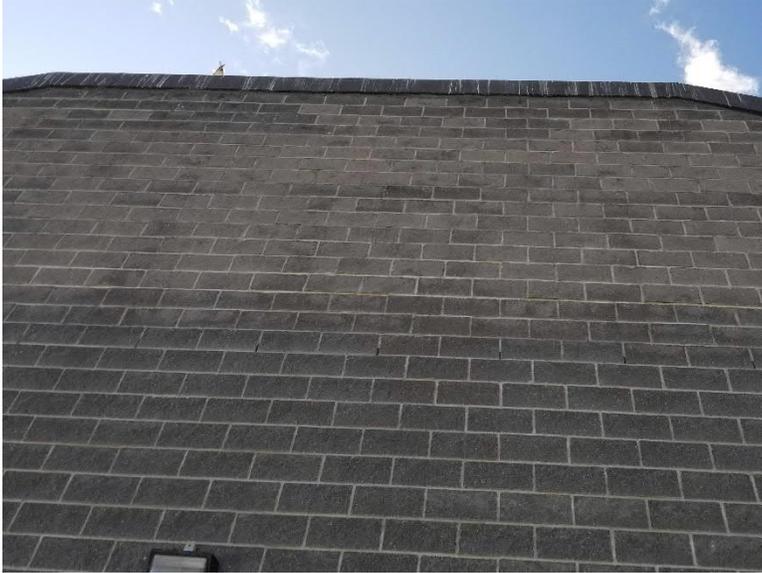
**Figure 30 Main Plant Building – Exterior - North Elevation Parapet Wall**

- The north elevation parapet wall extending above the roof line is discolored which is evidence of leaking along with the signs of leaking on the inside of the building in the membrane room. This is a result of the back side of the parapet wall above the roof line not cladded and waterproofed. This waterproofing should tie in with the roofing membrane and wrapped over the stone caps and flashed with prefinished metal (Figure 30 and Figure 31).

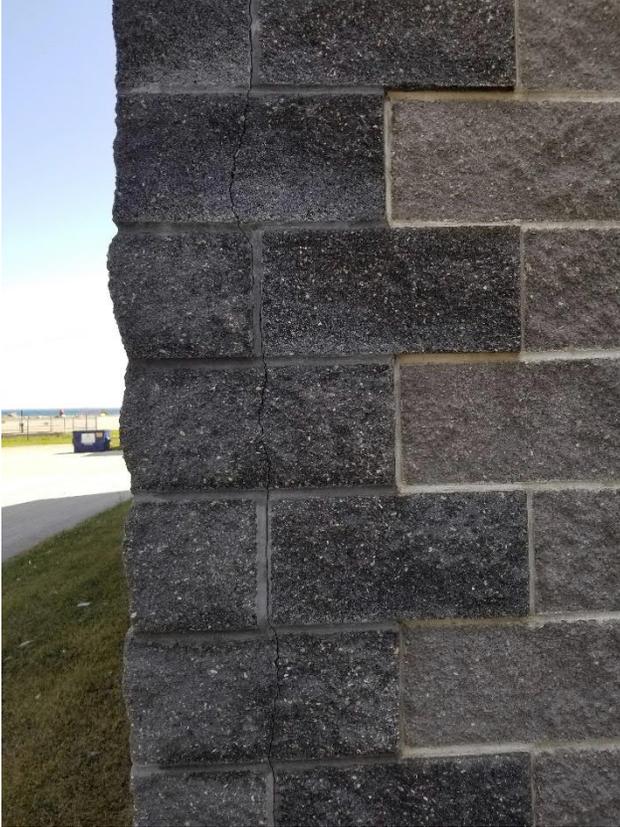
**Figure 32 Main Plant Building – Exterior - Architectural Block**

- The exterior architectural block is cracked vertically on the north-east corner, likely as a result of control joint placement (Figure 32).
- The exterior masonry control joints and other caulked joint locations such as around louvres and windows have dried out and require re-caulking (Figure 33).

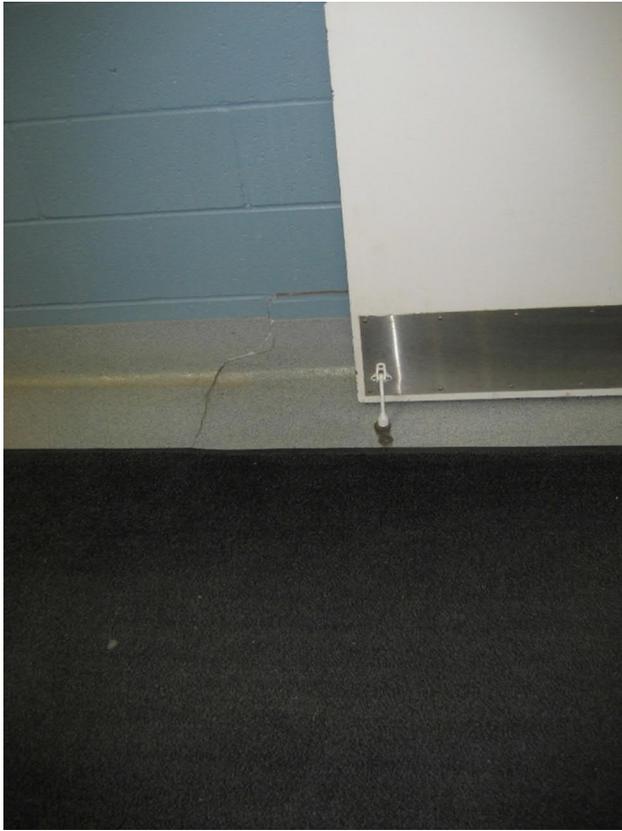
**Figure 34 Main Plant Building – Vestibule/Foyer - Ground Floor**

- Within the ground floor foyer area, wide cracks were observed in the floor slab and walls (Figure 34 and Figure 35).

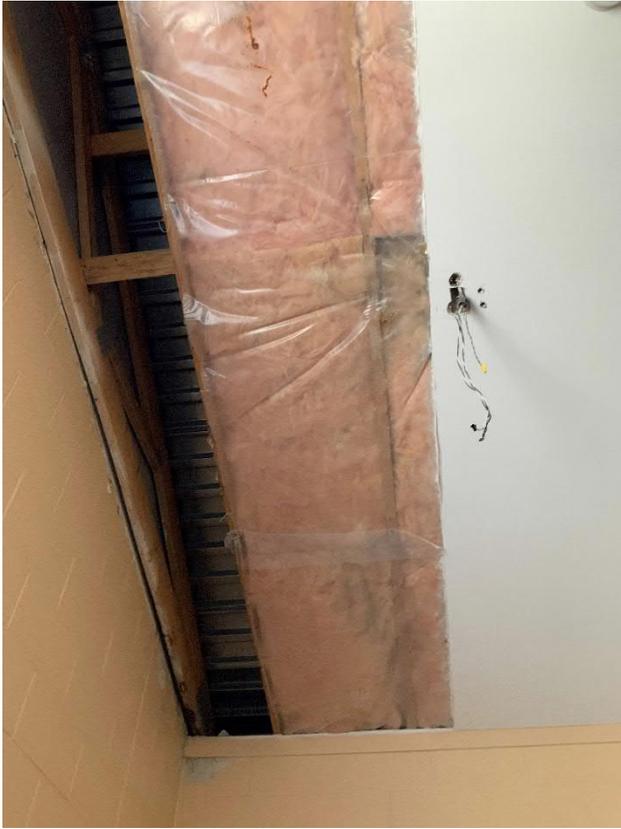
**Figure 37 Main Plant Building – Stair Second Floor – Ceiling**

- The guard rail in the stair is not compliant with the Ontario Building Code (OBC) in terms of graspable diameter, top and bottom terminations. The stair run also appears not to meet the required depth of the OBC (Figure 36).
- The stair is required to exit directly to the outside and not through the ground floor.
- The travel distance of a maximum 15m for one exit has been exceeded.
- The second floor ceiling in many areas needs to be replaced and repaired due to removals and repairs from roof leaks (Figure 37).

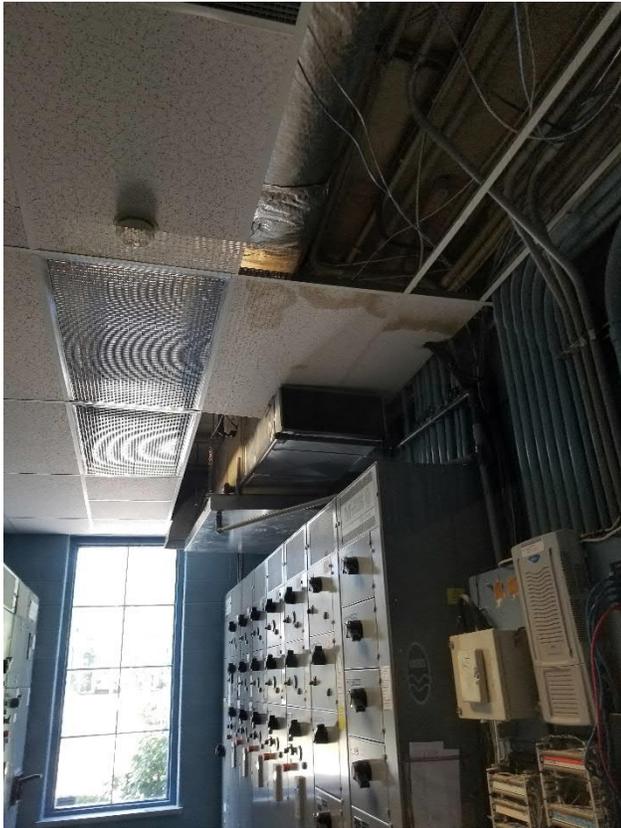
**Figure 38 Main Plant Building – Control Room/Office - Ceiling Tiles**

- There are missing, broken and damaged ceiling tiles some with evidence of water staining (Figure 38).

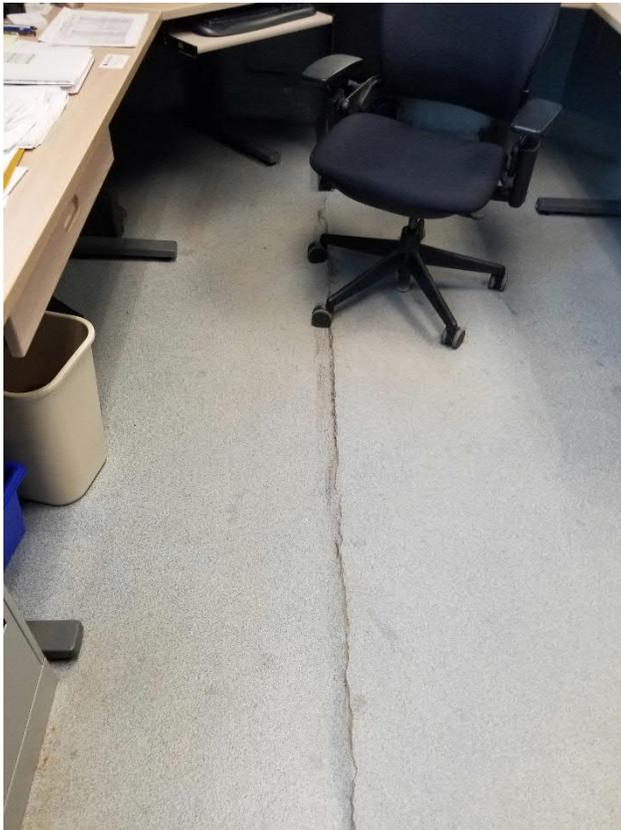
**Figure 39 Main Plant Building – Office - Floor**

- There are significant floor and wall cracks that are evident in all rooms running parallel to the west exterior wall caused by floor settlement. It is noted that AECOM were told by operations staff that noises of settlement can still be heard at times (Figure 39).

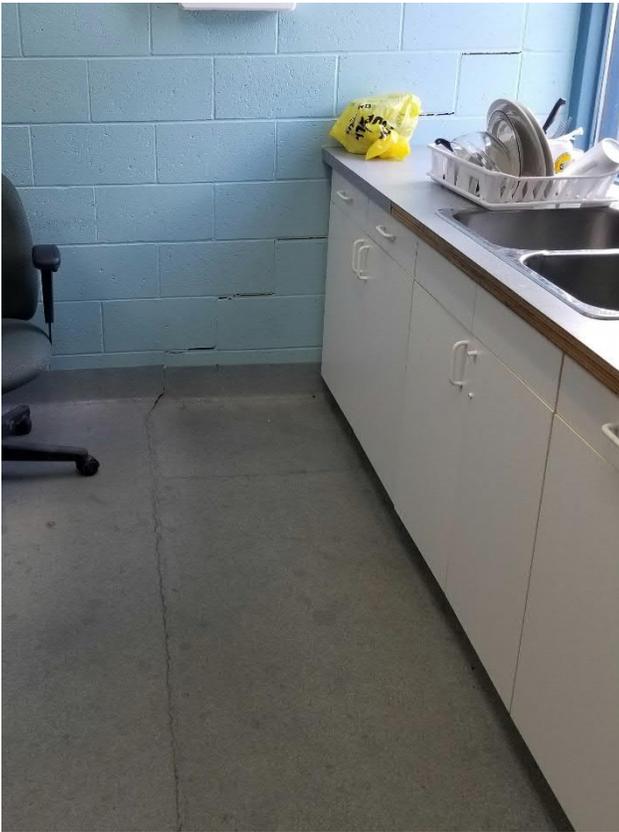
**Figure 40 Main Plant Building – Lunch Room - Floor**

- There are significant floor and wall cracks, likely due to the settlement issue (Figure 40).

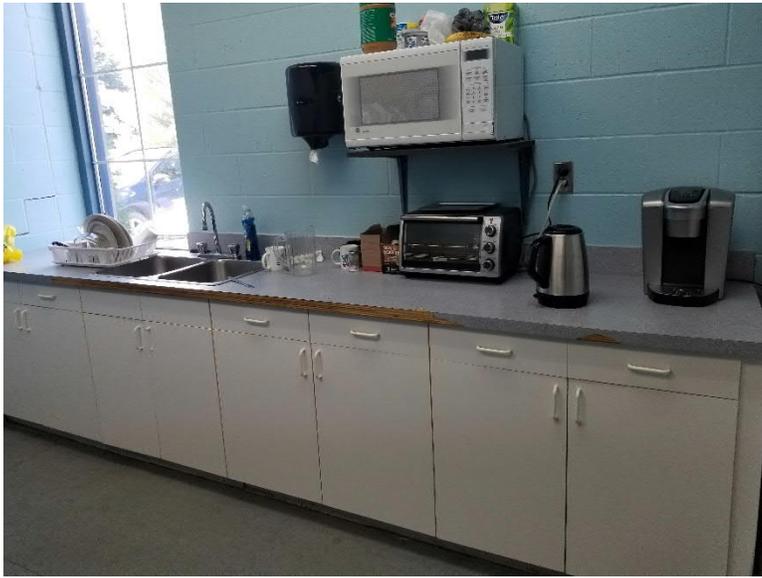
**Figure 41 Main Plant Building – Lunch Room - Counter Tops**

- The counter tops are worn and damaged (Figure 41).

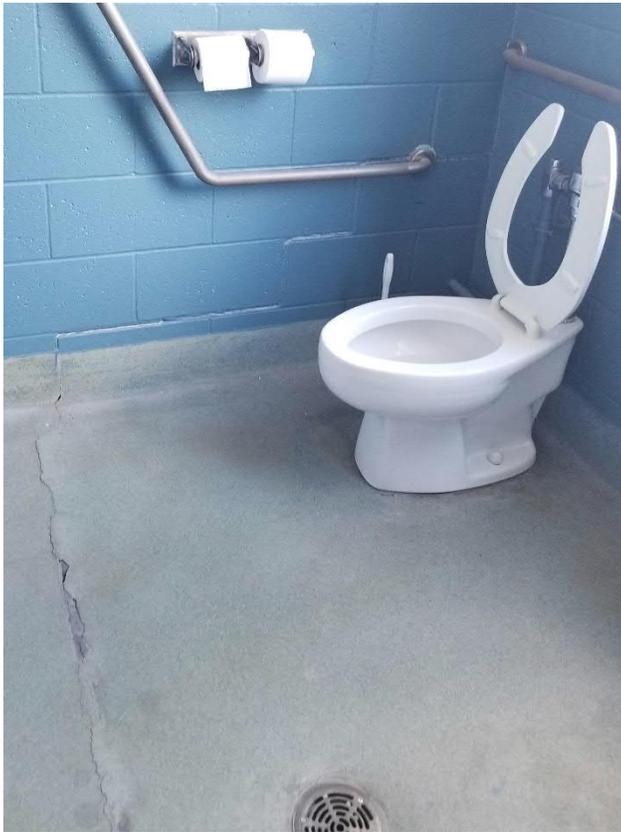
**Figure 43 Main Plant Building – Washroom - Floor**

- There are significant floor and wall cracks due to the settlement issues (Figure 43).

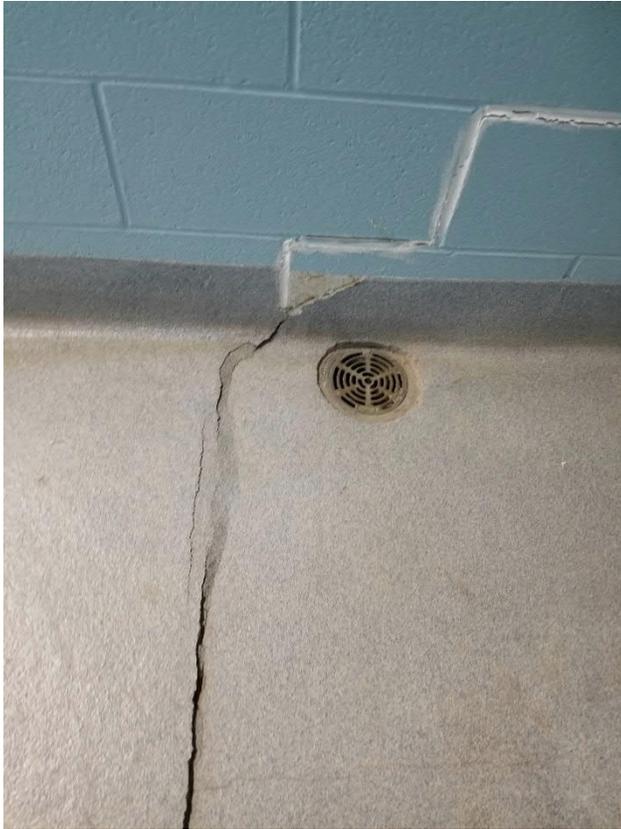
**Figure 44 Main Plant Building – Shower/Changeroom – Floor**

- There are significant floor and wall cracks due to the settlement issues (Figure 44).
- There is shower tile cracking due to the settlement issues (Figure 45).

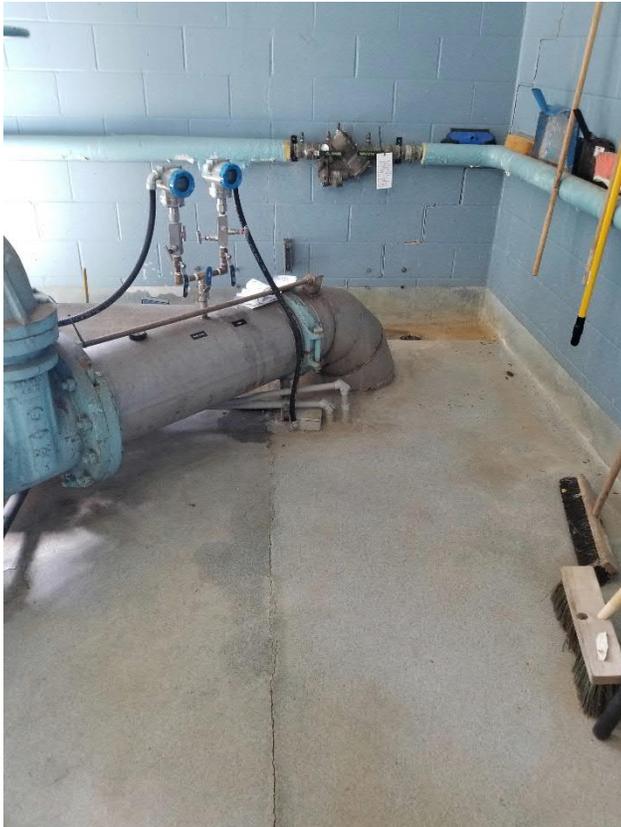
**Figure 46 Main Plant Building – High Lift Pump Room - Floor**

- There are significant floor and wall cracks due to the settlement issues (Figure 46).

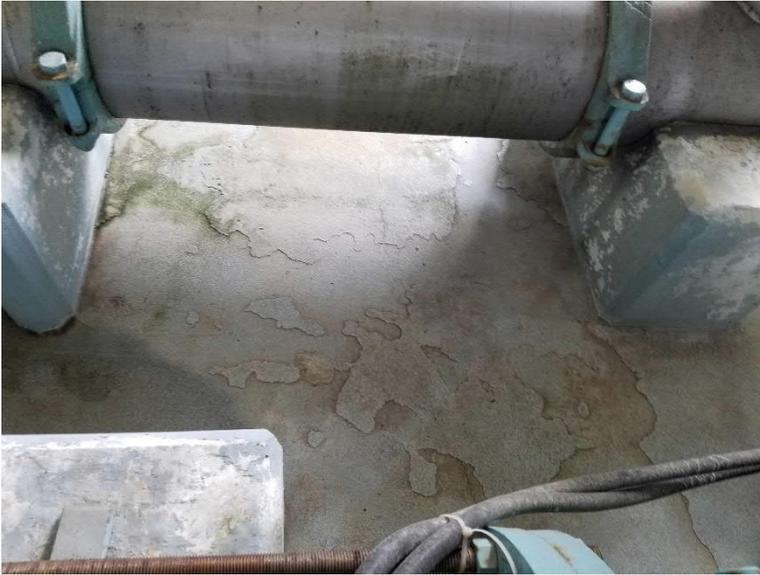
**Figure 47 Main Plant Building – High Lift Pump Room - Floor Epoxy**

- The floor epoxy finish is peeling and damaged in areas (Figure 47).
- There are wall and ceiling finish damages on the south wall due to parapet leaking (Figure 48).

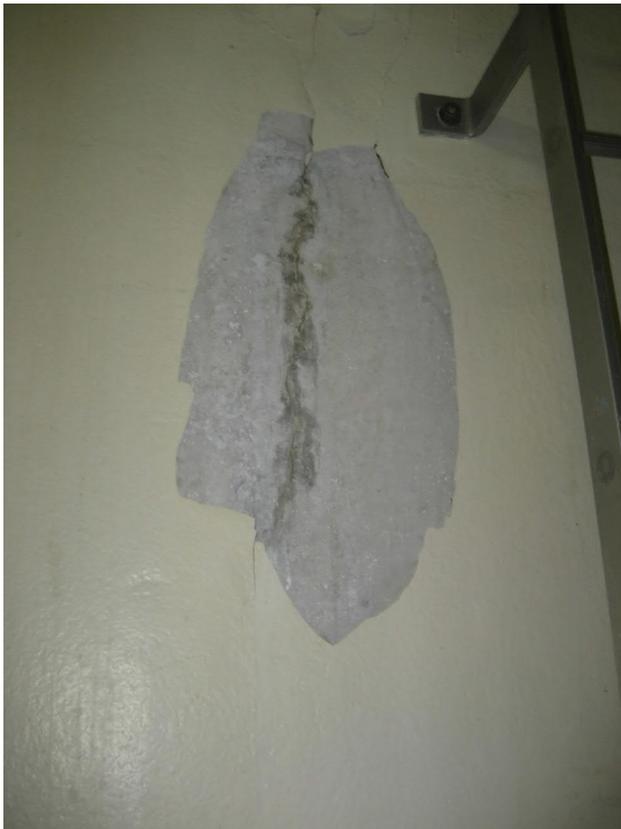
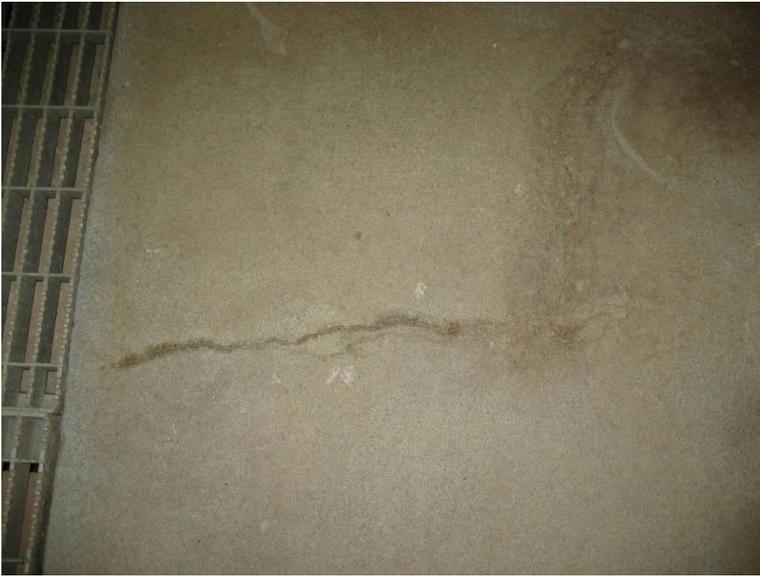
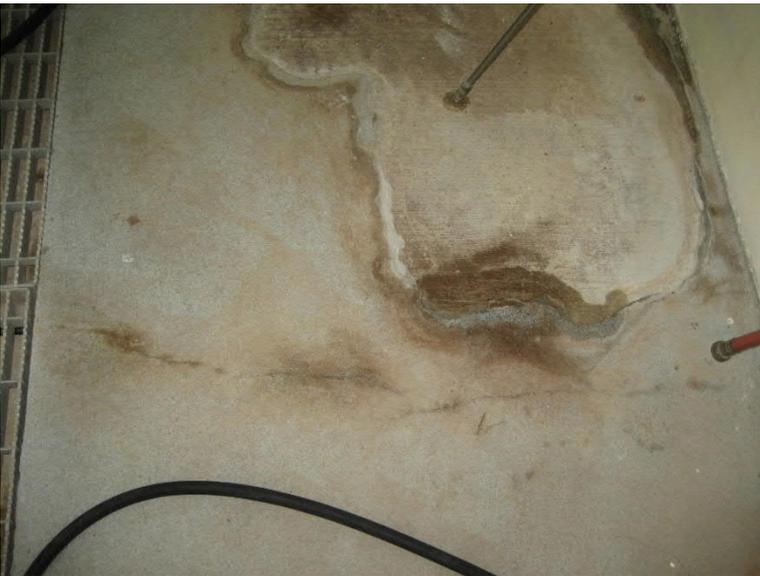
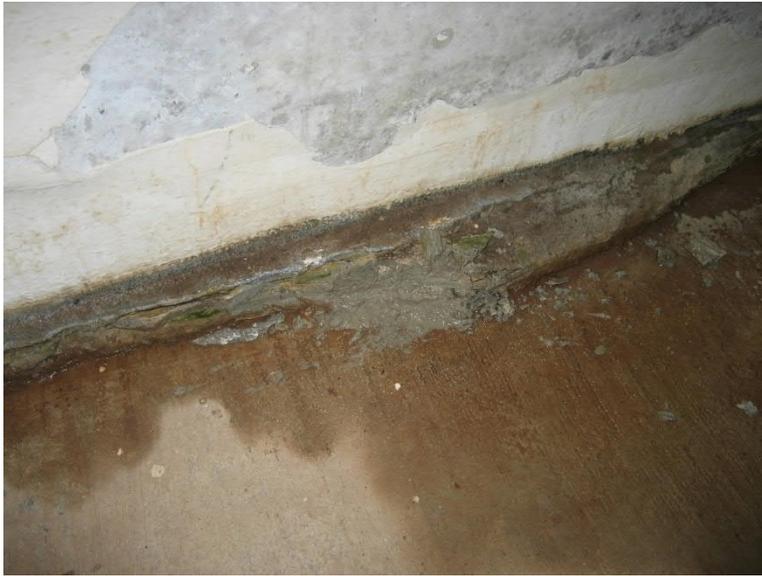
- Floor cracks or deteriorations (totaling approximately 4.0 m<sup>2</sup>) were observed in the walkway slabs of the Membrane Room (Figure 49, Figure 50, Figure 51 and Figure 52).

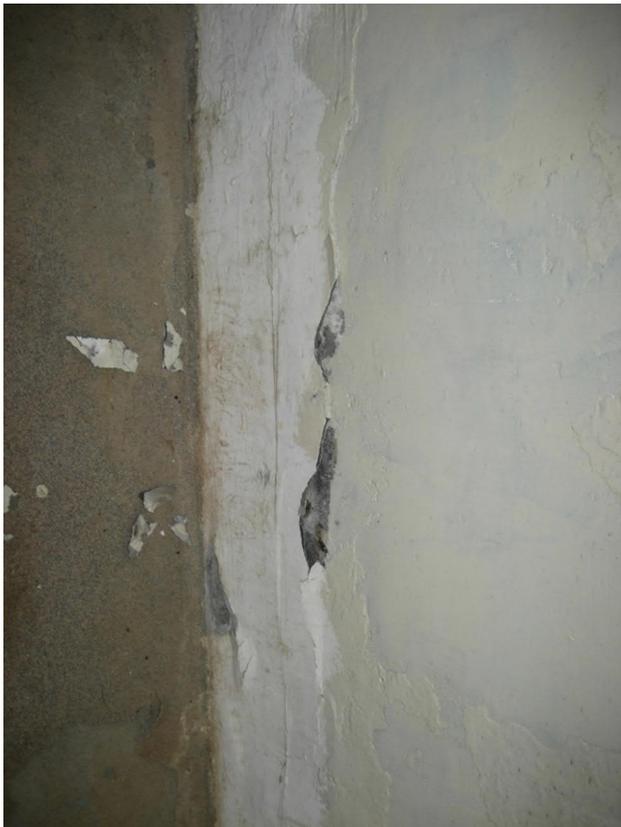
**Figure 53 Main Plant Building – Membrane Room - Wall Spalling**

- Concrete spalling (totaling approximately 1.0 m<sup>2</sup>) was observed at the bottom of the tank walls in the Membrane Room (Figure 53).
- Surface coat peeling (totaling approximately 4.0 m length), which is caused by concrete crack, insufficient surface preparation, mixing or application of coating, was observed at the tank walls in the Membrane Room (Figure 54). Regarding whether an improper HVAC system could be the cause for this crack, it should be noted that a specific crack may contribute to coating release by creating vapour drive behind the coating. If the coating system has been applied correctly with the appropriate system being used, the HVAC system should not influence the coating. However, a proper HVAC system will enhance the space and help alleviate peeling by providing drier conditions within the rooms.

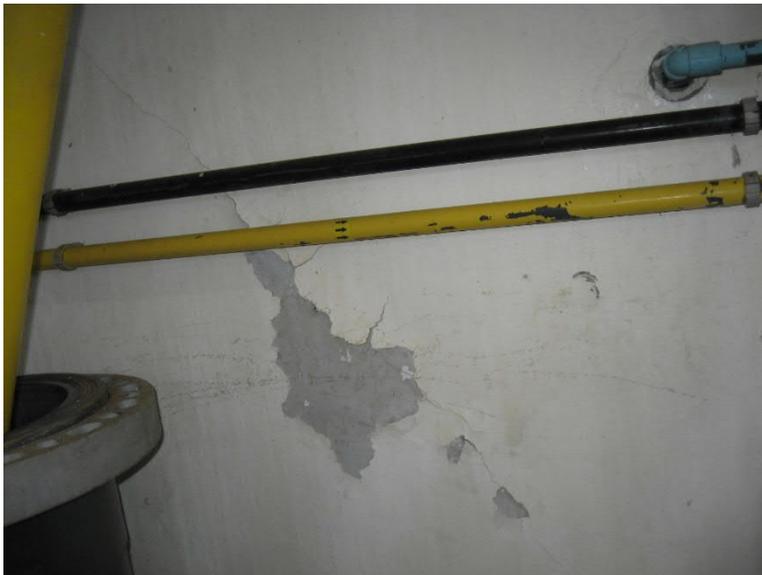
**Figure 55 Main Plant Building – Membrane Room - South Wall of Clean-in-Place (CIP) Tank**

- One wall crack (approximately 2.0m long) was observed in the south wall of the Clean-in-Place (CIP) Tank (Figure 55).
- In the corridor area outside (west) of the CIP Tank and Backpulse Tank, one crack (approximately 1.0m long) was found on the ground floor which is also the roof of the Chlorine Contact Chamber #2 (Figure 56).

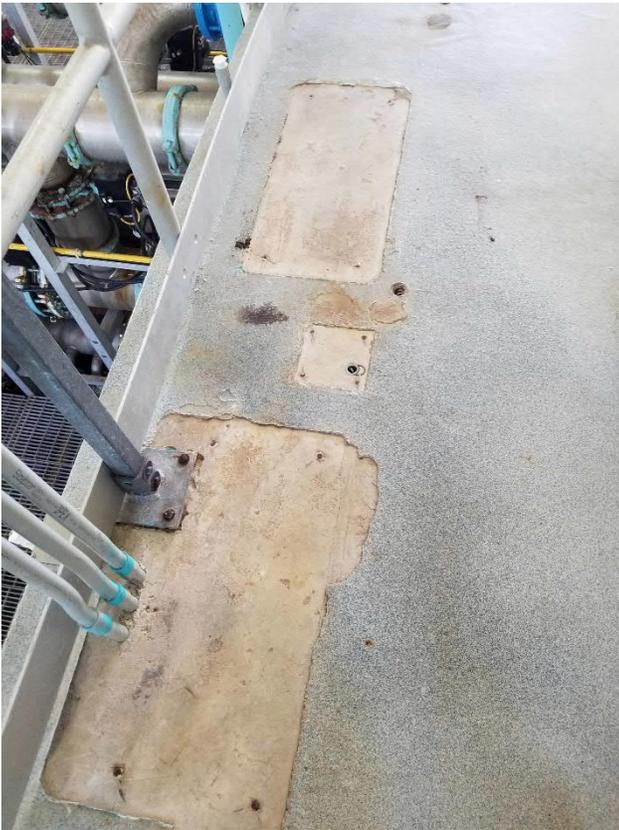
**Figure 57 Main Plant Building – Membrane Room - Floor Epoxy**

- The floor epoxy finish is peeling and damaged in areas as a result of equipment removals (Figure 57).
- Paint delamination issues can be found throughout the room including some ceiling areas (Figure 58).

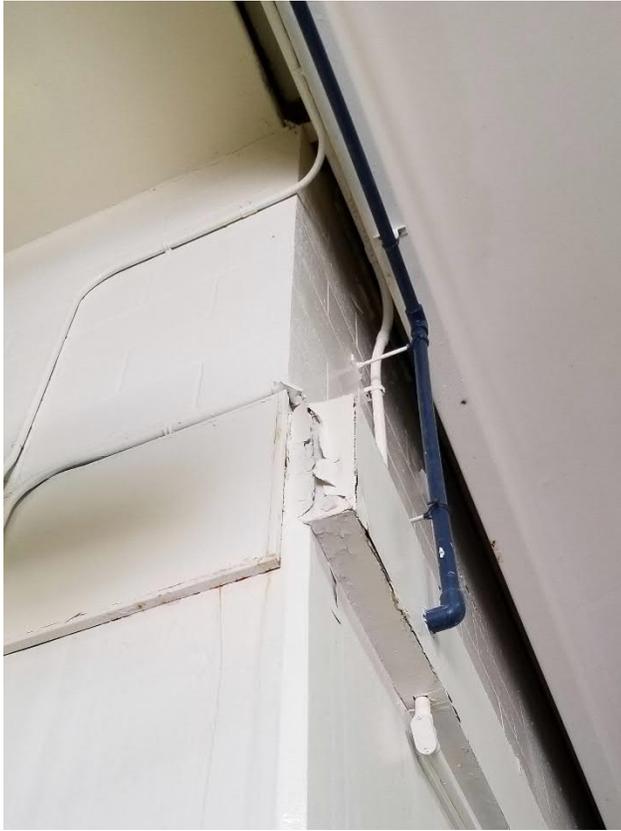
**Figure 59 Main Plant Building – Membrane Room - Control Room/Membrane Room Wall and Ceiling**

- Damage to the wall and ceiling finishes observed at the corner of the Control Room/Membrane Room appears to be a possible roof leak (Figure 59).
- The overhead door frames were severely corroded and need to be replaced (Figure 60). Regarding whether an improper HVAC system could be the cause for this corrosion, the corrosion is more related to the use of salting the slabs around the entrance. However, HVAC and proper venting of the space to remove humidity and chlorine would also help alleviate concerns related to corrosion.

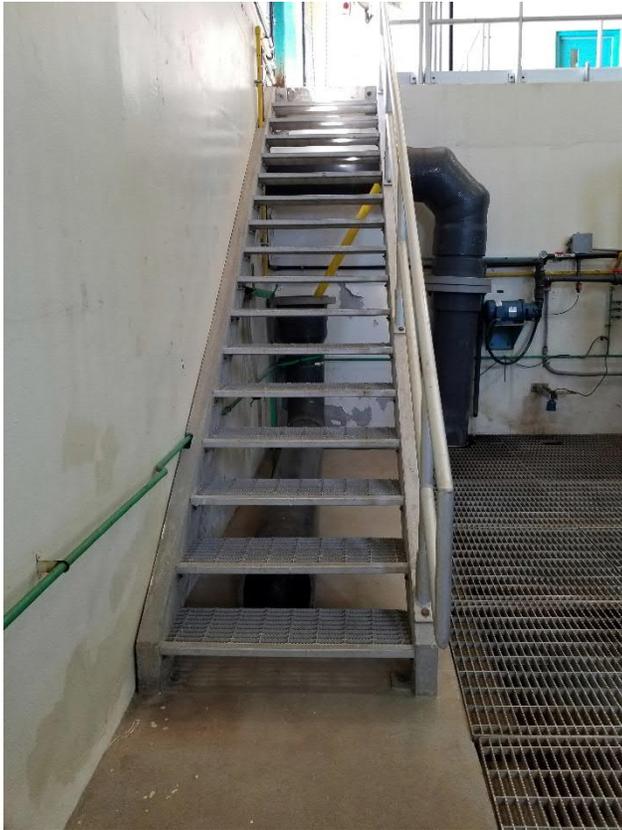
**Figure 61 Main Plant Building – Membrane Room - Stairs**

- All of the stairs in the Membrane Room have guardrail/railings too large in diameter to meet code (Figure 61). This could be resolved with the inclusion of a handrail mounted to the wall face.

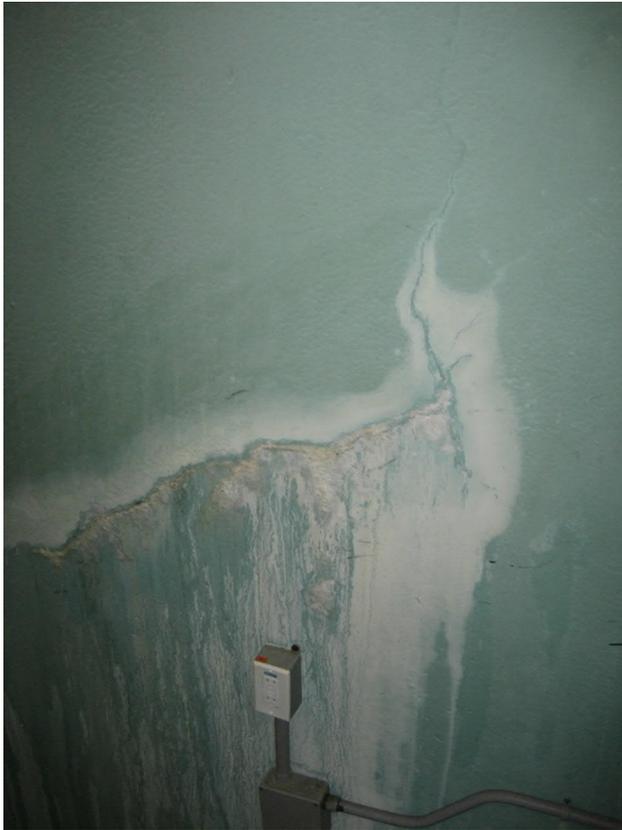
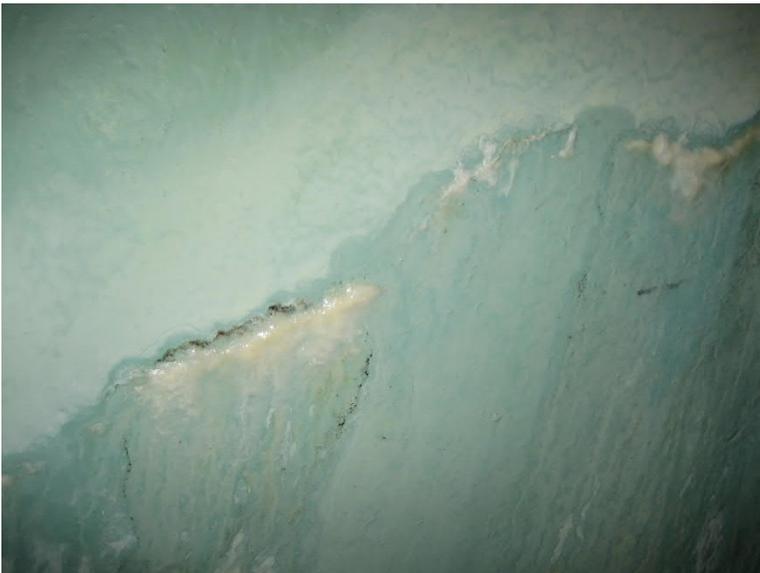
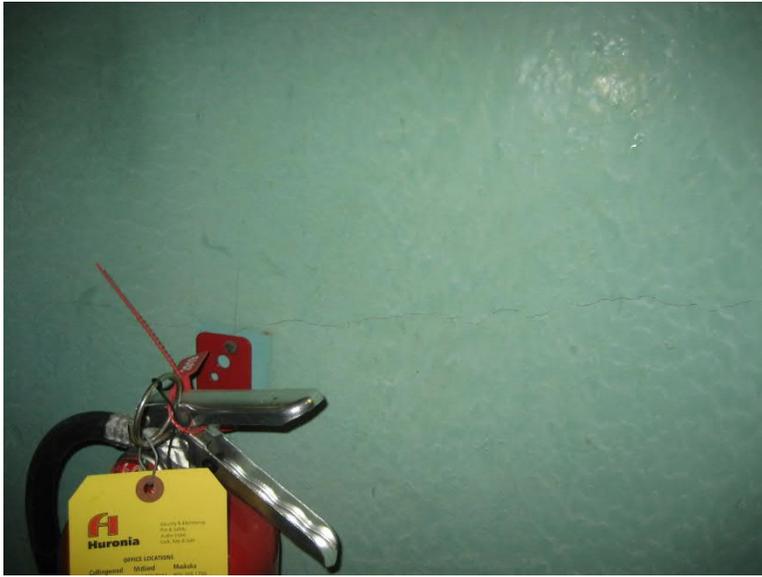
- Wall cracks, one in the horizontal and the rest in the vertical or diagonal directions for a total of approximately 22m length, were observed in the Membrane Piping Gallery (Figure 63, Figure 64 and Figure 65).
- One 15m long longitudinal floor crack along the columns and several other floor cracks totaling approximately 22m in length, were found in the base slab of the Membrane Piping Gallery (Figure 66 and Figure 67).

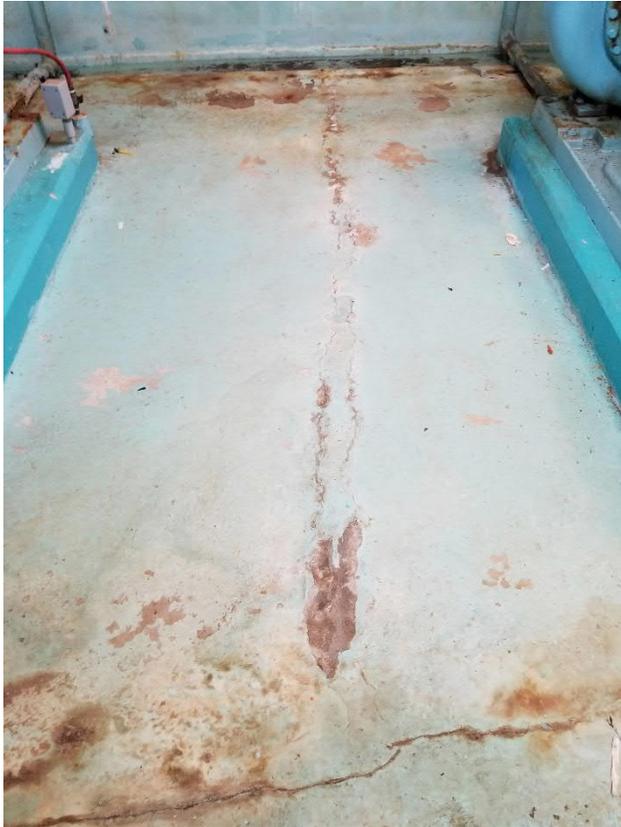
**Figure 68 Main Plant Building – Membrane Piping Gallery – Epoxy Floor**

- Paint finishes on the walls and ceiling are damaged with peeling observed in various locations.
- The epoxy floor finishes are in poor condition (Figure 68).
- The guard rail on the stair is not compliant with the OBC in terms of graspable diameter, top and bottom terminations.

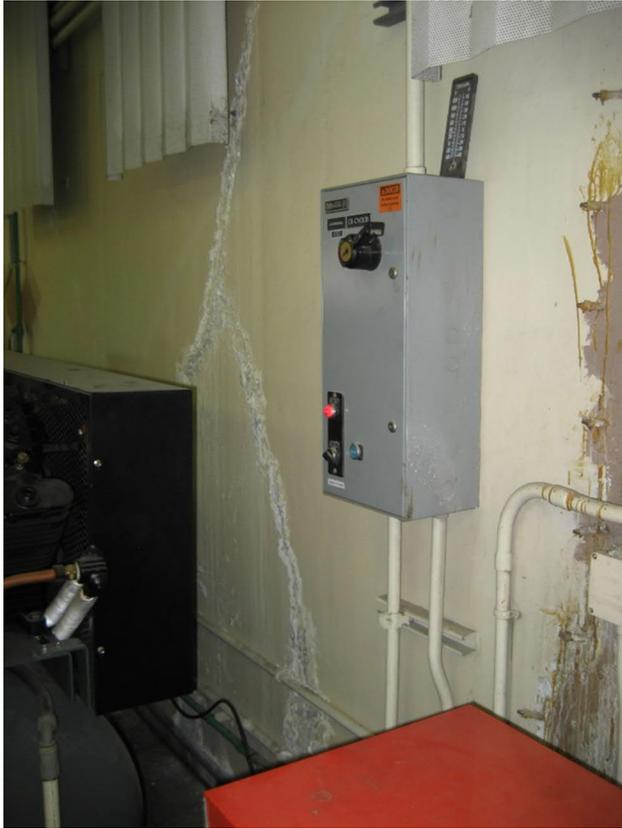
**Figure 69 Main Plant Building – Blower Room – West Wall**

- Several cracks, some of which had been injection-repaired before with injection ports left in place, were noted in west wall of Blower Room which shares a wall with the CIP Tank (Figure 69). Other leaking cracks were observed resulting in damaged paint finishes.
- There are cracks in the walls and floor through the Blower room running in a north-south direction close to the east wall. This is caused likely by combination of building foundation systems and earth settlement (Figure 70).

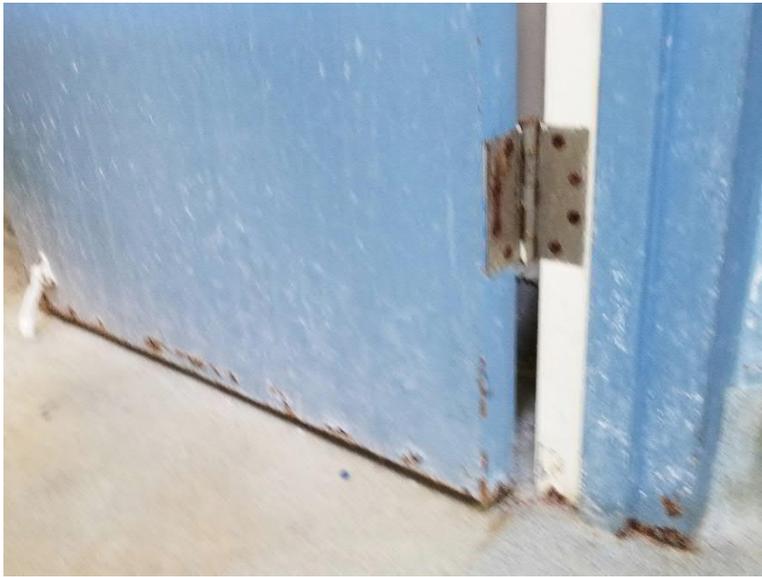
**Figure 72 Main Plant Building – Chlorination Control Room - Metal Door and Frame**

- The hollow metal door and frame are severely corroded and require replacement (Figure 72).
- Epoxy floor finishes are heavily damaged along with wall paint around the base of the walls due to chemical exposure.

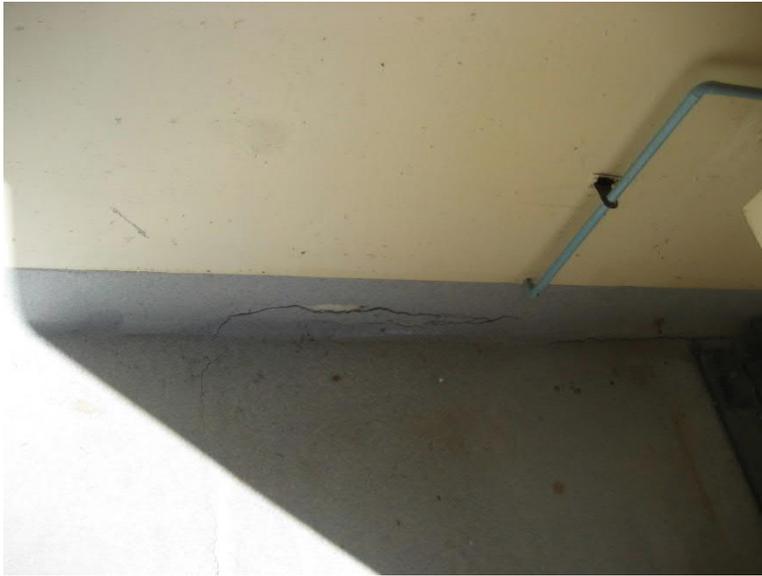
**Figure 73 Main Plant Building – Chlorination Room - Chlorination Room**

- There are cracks in the walls and floor through the Chlorination Room running in a north-south direction close to the east wall (Figure 73). It is noted from the record drawings that this crack is along the boundary of a suspended slab and slab-on-grade. This crack is caused likely by a combination of building foundation systems and earth settlement.
- A 2m long and 3m long wall crack (each greater than 1.0mm in width) were noted in the south wall in the Chlorination Room. (Figure 74).

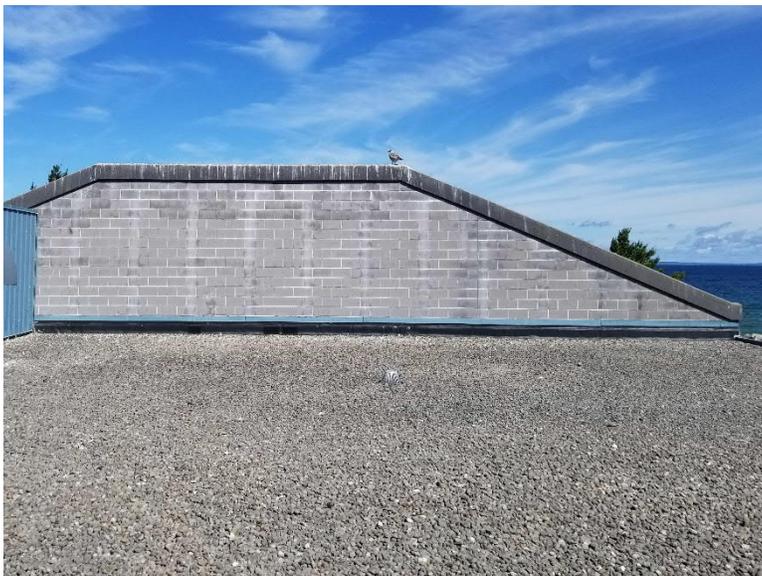
**Figure 75 Main Plant Building - Roof**

- The flat roof with membrane system has reached the end of its service life and is actively leaking and is currently scheduled for replacement (Figure 75).
- The north and south elevation parapet wall extending above the roof line is discolored which is evidence of leaking. This evidence is also seen given leaking on the inside of the building in the membrane room. This is a result of the back side of the parapet wall above the roof line not being cladded and waterproofed. This waterproofing should tie in with the roofing membrane and wrap over the stone caps and flashed with prefinished metal (Figure 76).
- The metal roofing has exhibited some leaking which is currently under repair. There are also some loose fasteners, some corroded screws and washers and finish deterioration (Figure 77).

The Town requested that AECOM provide details of the suggested repairs to the flat roofing of the main plant building so that they can be added to the specifications for roofing repairs currently being undertaken by the Town. The Town would like the details of the roof conditions to compare with secondary quote/assessment.
