**PHASE ONE
ENVIRONMENTAL SITE ASSESSMENT
PART OF LOTS 47, 48, AND 49, CONCESSION 12,
TOWN OF COLLINGWOOD, ONTARIO**

Prepared for: **Huntingwood Trails (Collingwood) Ltd.**
243 Hurontario Street
Collingwood, ON L9Y 2M1

File No 3-21-0151-41
September 8, 2023
©**Terraprobe Inc.**

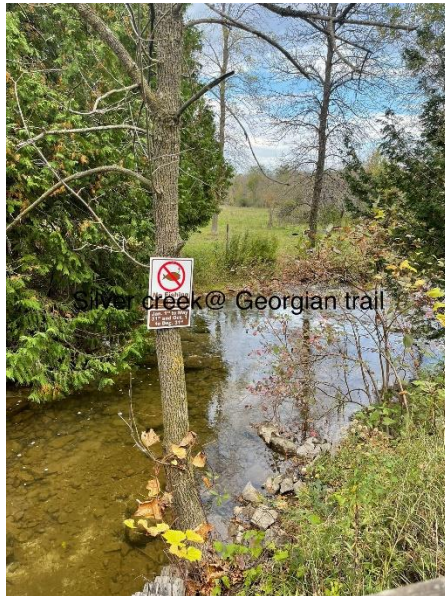
Photograph 1

Viewing: Northwest portion of Phase One Property

Description: Pasture lands observed for cattle grazing towards the site entrance from Silver Creek Drive

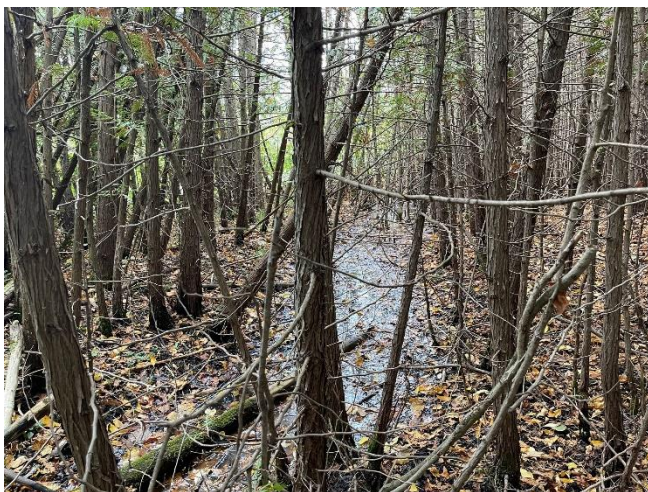
Photograph 2

Viewing: Silver Creek

Description: Silver Creek flowing south to north through the central portion of the Property

Water Sources	Silver Creek runs through the western portion of the Property and is the source of water on the Property.
Current and Former Wells	No wells were observed on the Property.
Sewage Works	No sewage is generated on the Property.
Railways	No railways were located on the Property.
Stained and Odorous Soils	No stained or odorous soils were observed at the Property during the site inspection.
Stressed Vegetation	No areas of stressed vegetation were observed on the Property during the site inspection.
Underground Utilities and Services	Underground utilities may be present on the Property.
Fill Materials	No fill material was observed during the site inspection.
Watercourses, Ditches or Standing Water	Silver Creek was observed towards the western portion of the Property, flowing south to north.

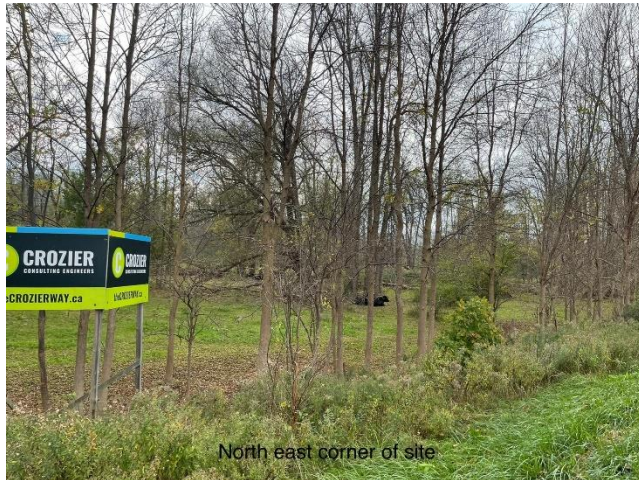
Photograph 4

Viewing: East Property Boundary

Description: East Property boundary and adjacent residential subdivision

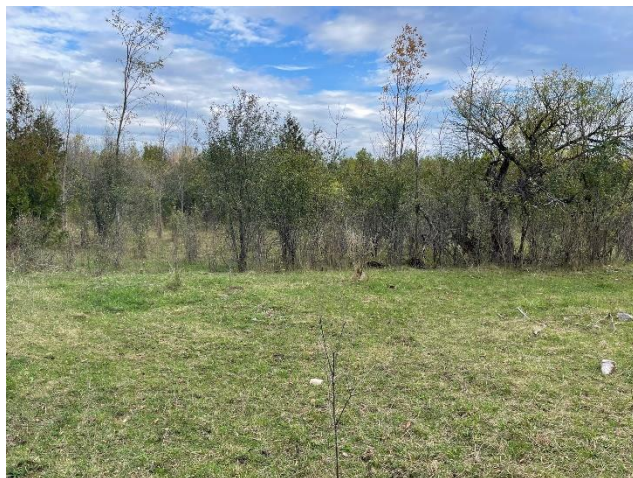
Photograph 5

Viewing: Northeast portion of Phase One Property

Description: Pasture lands for cattle grazing
